Roanoke, Town of
(Thomas Feeney House)
Roanoke
Lewis County
West Virginia

HABS No. WV-209-I

WRITTEN HISTORICAL AND DESCRIPTIVE DATA

ROANOKE, TOWN OF
(Thomas Feeney House)

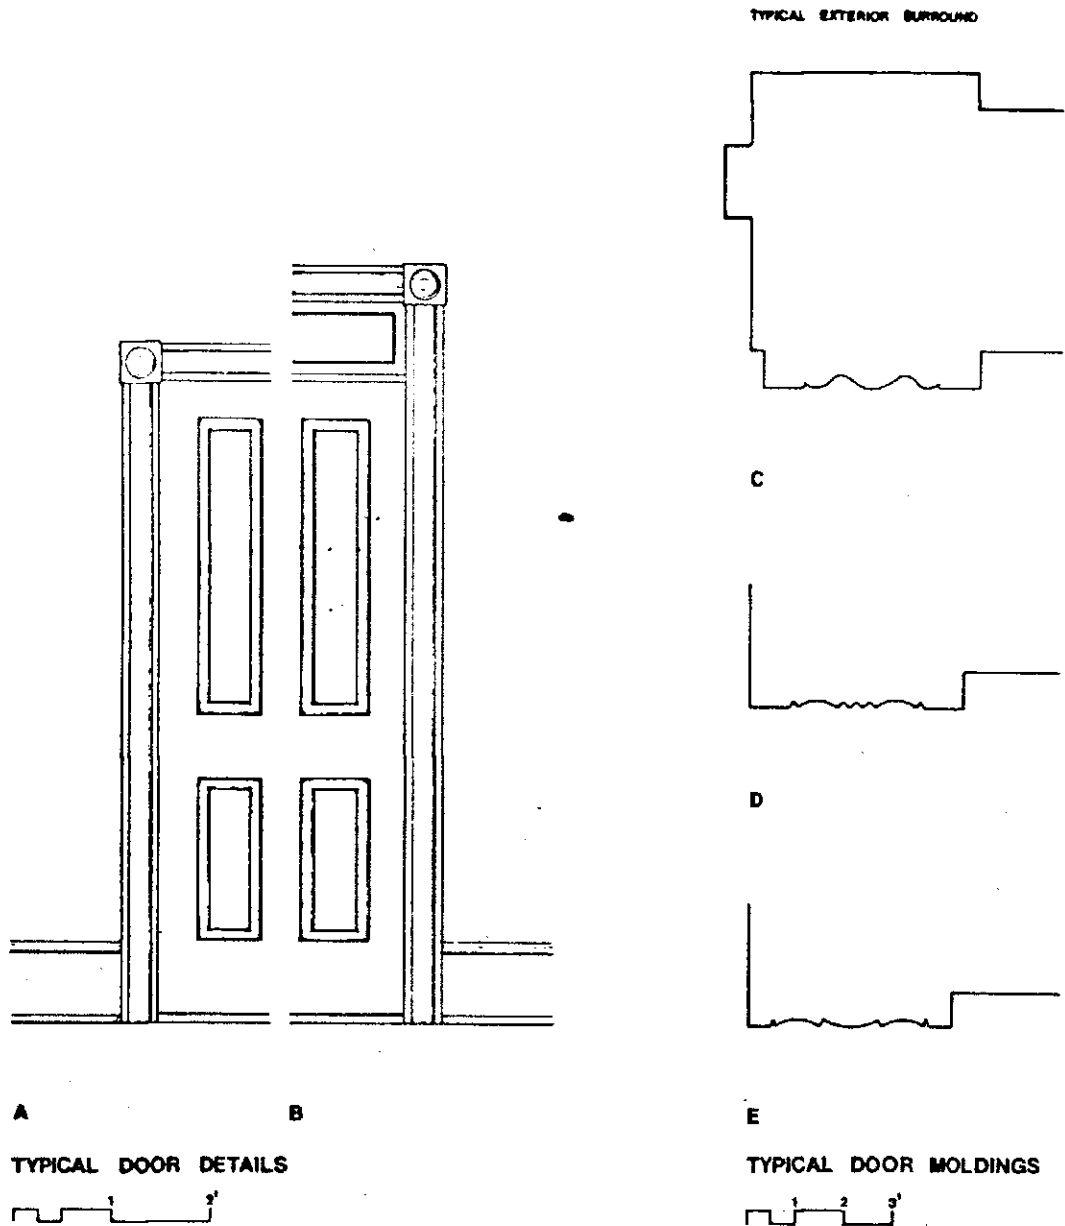
Typical door details in the Feeney dwelling.

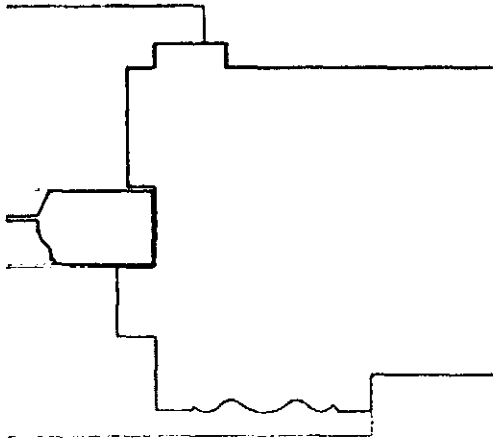
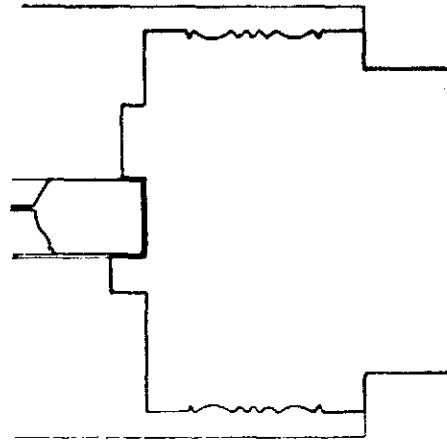
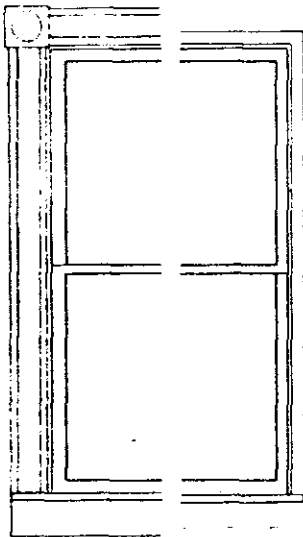
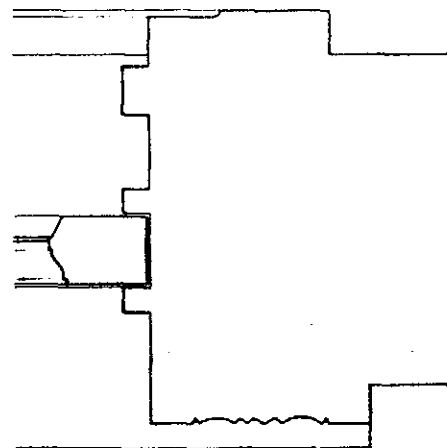
TYPICAL WINDOW DETAILS

Typical window details in the Feeney dwelling.

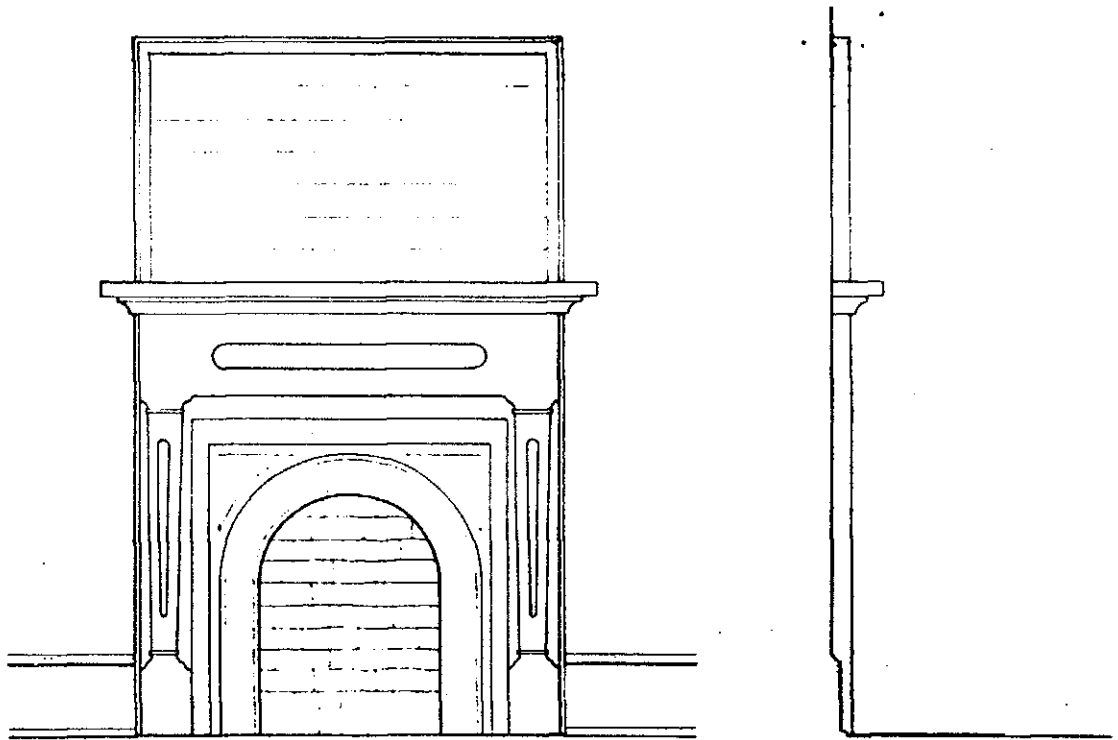
FIREPLACE MANTEL ROOM 2

Fireplace mantle details in Room 2 of the Feeney dwelling.

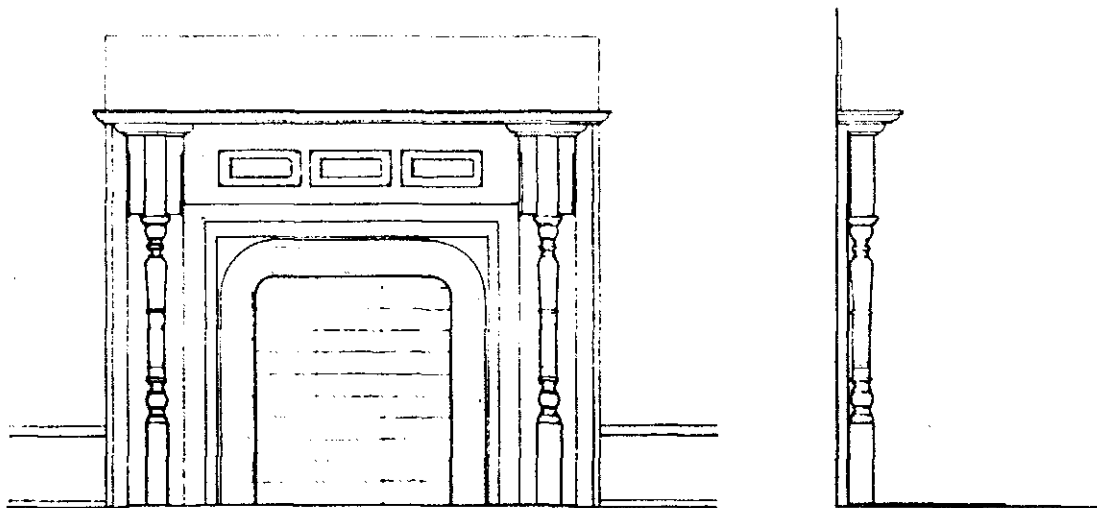
FIREPLACE MANTEL ROOM 4

Fireplace mantle details in Room 4 of the Feeney dwelling.
